Manhole Inspection Summary

Manhole # S31WW1017MH

Insp Date: **1/23/07 12:36 PM**

Location Address: **110 ENFIELD RD**

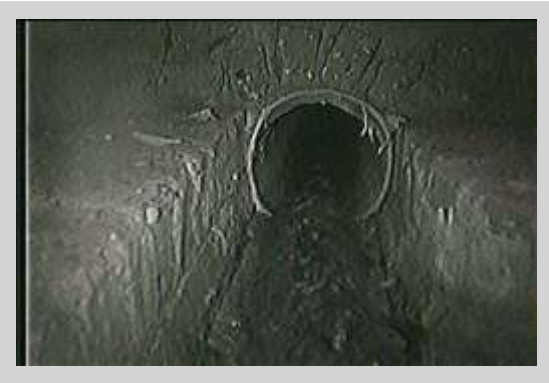
8 in. Circular Gravity Sewer Pipe Out @ 12 O'Clock

Pipe Material: **Unknown** ☒ Pipe Lined

Infiltration: **None** Pipe Seal Cond: **Unknown**
